# ADVANCED SOLUTIONS FOR ASSESSMENT OF EXISITING CONCRETE DAMS

## Ipto Dam test

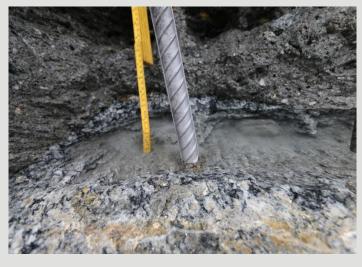
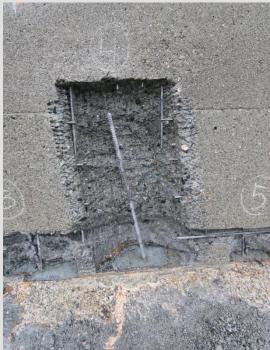
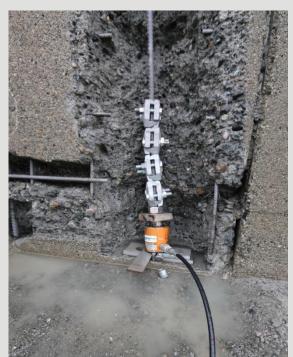
#### NDT tools used

- MIRA ultrasound 3D tomographer
- GPR system
- Reinforcement cover meters

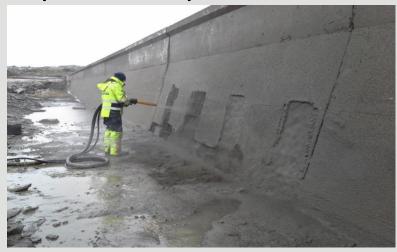
- Rock bolts were detected every 800 mm, No damage due to corrosion was observed (by NDT and drilling)
- No substantial discontinuity or air interface found between dam and bedrock
  - Friction and Matedness
- Bedrock was found intact upto 2 m depth
